Pre-Completion Snagging Report Sample

Created: 16 Nov 2022

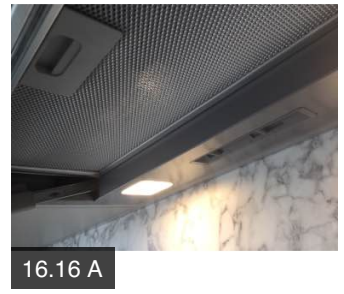
16.15 A

16.15 Extractors		Fail	The kitchen extractor was tested however there was no level of effective extraction at the time of inspection.		
	Action	Assignee	Due Date	Complete?	Action Comments
	Test and rectify extractors	Ventilation Engineer	N/A	No
